# Inspection Report

**Property Address:**

17040 Serengeti Cir

## MEF Home Inspections LLC

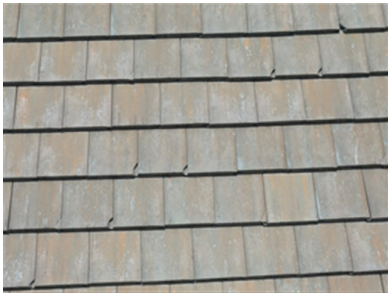
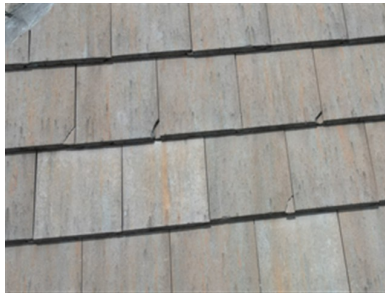
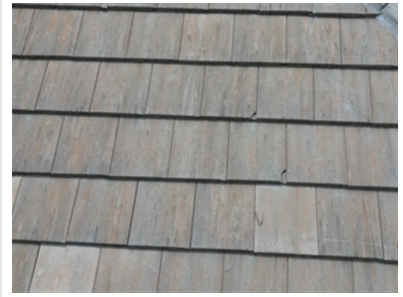
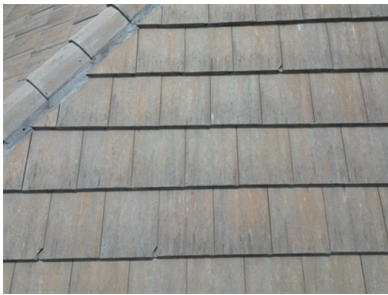
(1) The interlocking concrete tile roof had a number of broken lower right corners. Tiles are thinnest at their edges where they interlock and lower corners are the weakest part of these thin areas. Tiles with broken sections that do not exceed the overlap (typically 3 inches) can be repaired. Tiles with broken sections that exceed the overlap should be replaced. All work should be performed by a qualified roofing contractor.

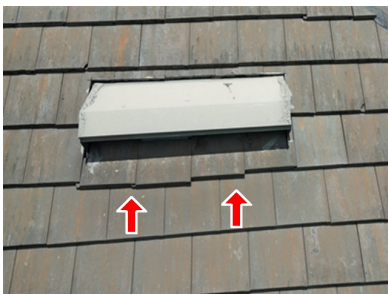
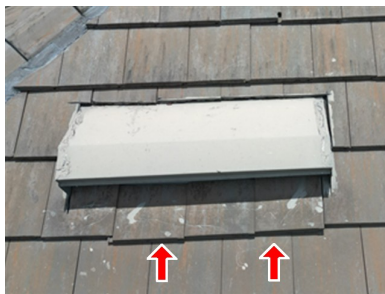
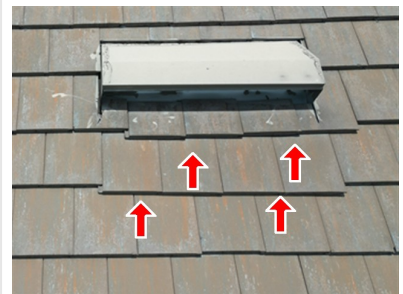
(2) Roof tiles had been displaced. This is typically wind damage and may indicate inadequate fastening. The tiles should be replaced by a qualified roofing contractor in a manner that will hold them securely in place.

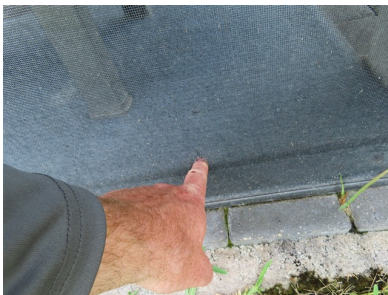
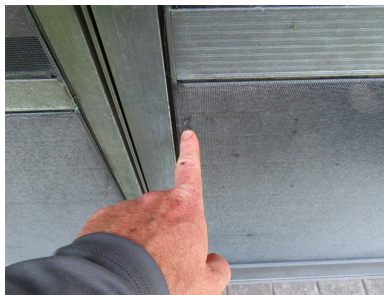
(1) At the rear porch, damaged screening should be replaced by a qualified contractor.

(1) At the rear porch, damaged screening should be replaced by a qualified contractor.

[Not repairing](#)

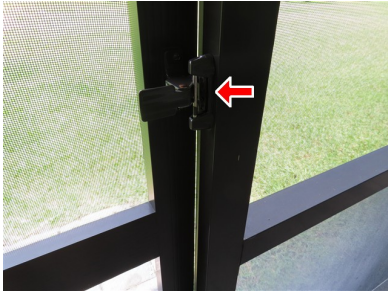
4.5 Item 3 (Picture)

(2) Rear porch door did not self close, and binds on frame when trying to close. Correction should be made by a qualified contractor.

(2) Rear porch door did not self close, and binds on frame when trying to close. Correction should be made by a qualified contractor.

[Repairing](#)

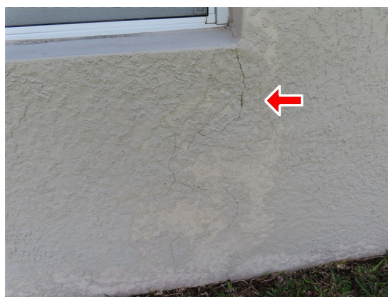
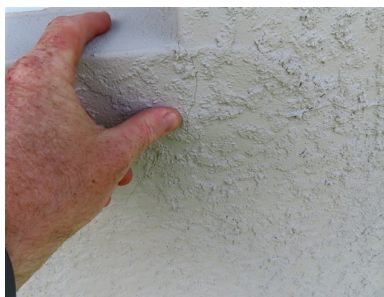
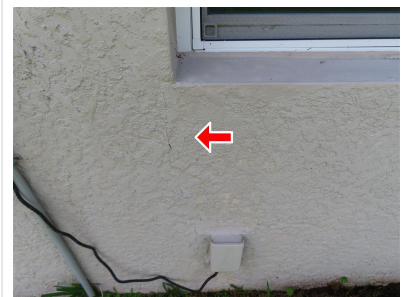
Minor to Moderate cracking was visible in stucco covering exterior walls of the home. Cracks exceeding 1/16-inch in width should be filled with an appropriate material to prevent future damage from moisture and monitored in the future for continued activity.

Minor to Moderate cracking was visible in stucco covering exterior walls of the home. Cracks exceeding 1/16-inch in width should be filled with an appropriate material to prevent future damage from moisture and monitored in the future for continued activity.

[Not Repairing](#)

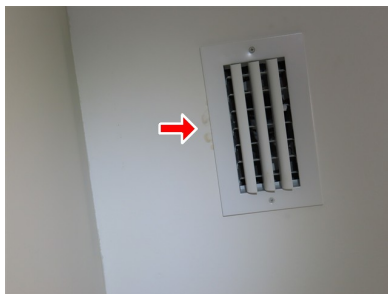
7.2 Item 2 (Picture)

(2) Stains present at air conditioning duct in master bathroom were caused by condensation from ducts. No elevated moisture was present at time of inspection.

(2) Stains present at air conditioning duct in master bathroom were caused by condensation from ducts. No elevated moisture was present at time of inspection. [A/C Condensation. Repaired. Painting.](#)

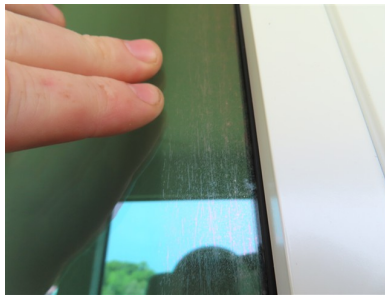
(1) Condensation visible in the double-pane glazing of sliding glass doors indicated a loss of thermal integrity due to failed seals. The Inspector recommends that before the expiration of your Inspection Objection Deadline you consult with a qualified contractor to discuss options and costs for replacement.

(1) Condensation visible in the double-pane glazing of sliding glass doors indicated a loss of thermal integrity due to failed seals. The Inspector recommends that before the expiration of your Inspection Objection Deadline you consult with a qualified contractor to discuss options and costs for replacement. [Not Repairing](#)

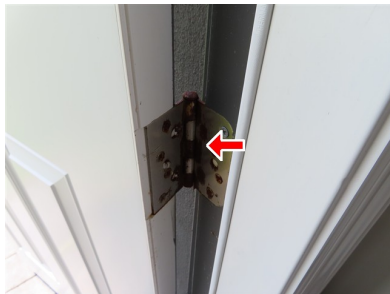
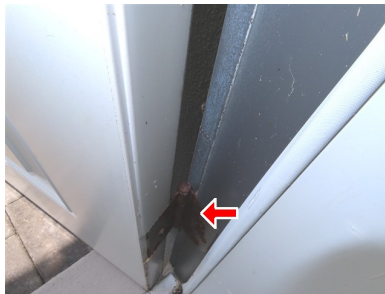
(2) Doors hinges at rear conventional door at 2nd shared bathroom are severely weathered making it difficult to operate door. Repairs should be made by a qualified contractor.

(2) Doors hinges at rear conventional door at 2nd shared bathroom are severely weathered making it difficult to operate door. Repairs should be made by a qualified contractor. [Repairing](#)

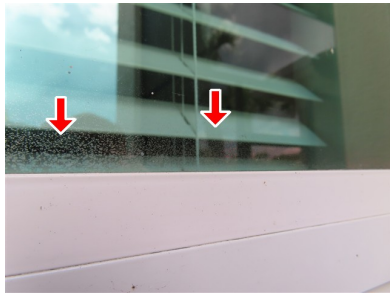
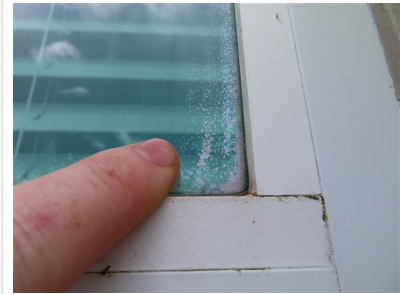
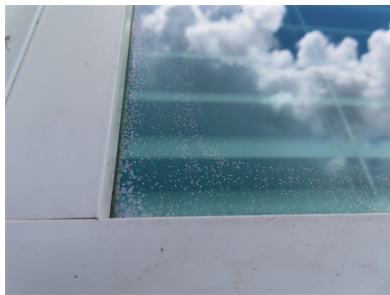
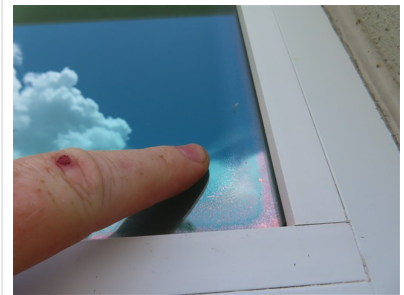
Condensation visible in the double-pane glazing of a number of windows indicated a loss of thermal integrity due to failed seals. The Inspector recommends that before the expiration of your Inspection Objection Deadline you consult with a qualified contractor to discuss options and costs for replacement.

Condensation visible in the double-pane glazing of a number of windows indicated a loss of thermal integrity due to failed seals. The Inspector recommends that before the expiration of your Inspection Objection Deadline you consult with a qualified contractor to discuss options and costs for replacement. [Not Repairing](#)

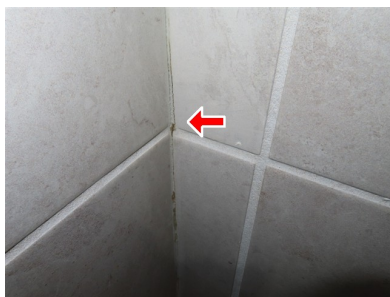
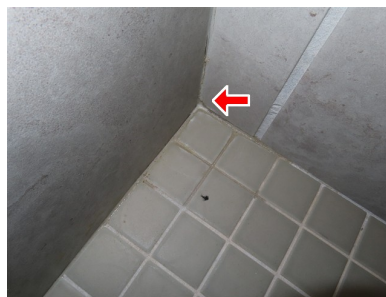
Grout maintenance needed at shower tiles in 2nd shared bathroom shower.

Grout maintenance needed at shower tiles in 2nd shared bathroom shower. [Repairing](#)

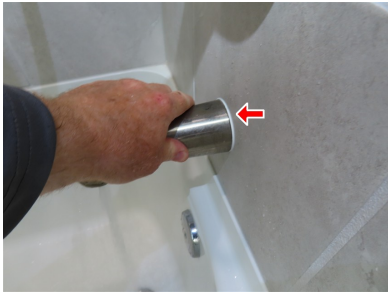
8.7 Item 1 (Picture)

Bathtub nozzle was loose and needs sealant maintenance.

Bathtub nozzle was loose and needs sealant maintenance. [Repairing](#)
